**Vulnerability Assessment of Typical Residential Buildings of  
Chattogram City Corporation with Post Seismic Hazard Consideration**

**DEPARTMENT OF DISASTER ENGINEERING AND MANAGEMENT  
CHITTAGONG UNIVERSITY OF ENGINEERING & TECHNOLOGY  
CHITTAGONG, BANGLADESH  
December, 2024**

**A Project Report**

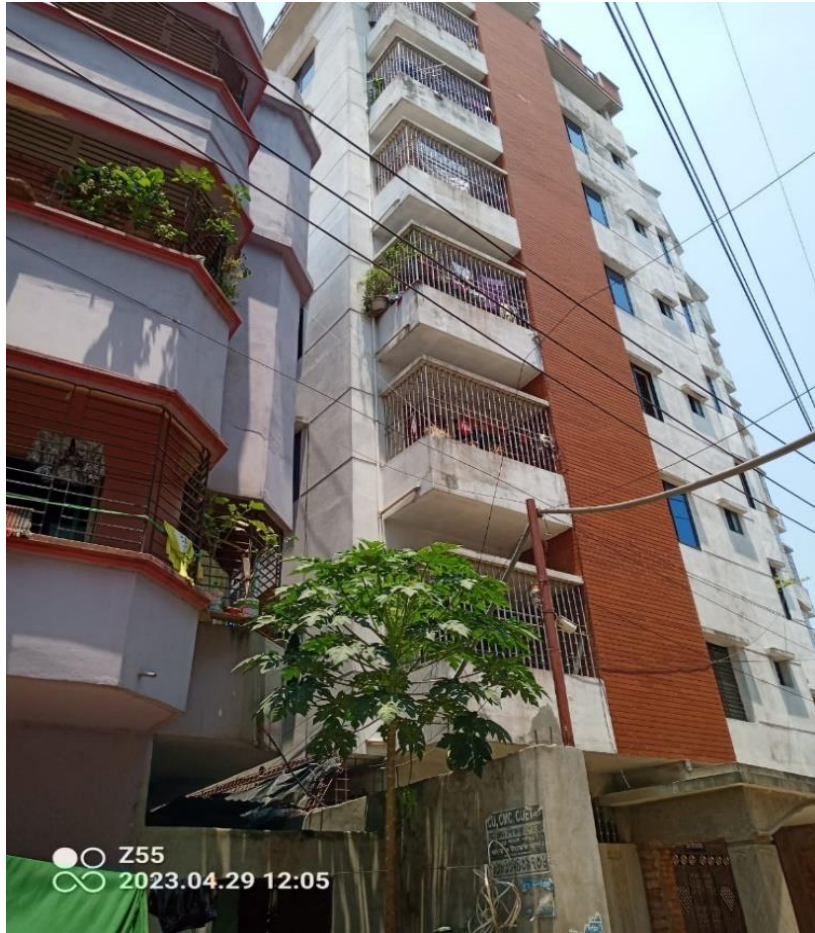
**Figure 2.10:** An adjacent building view of Chattogram city

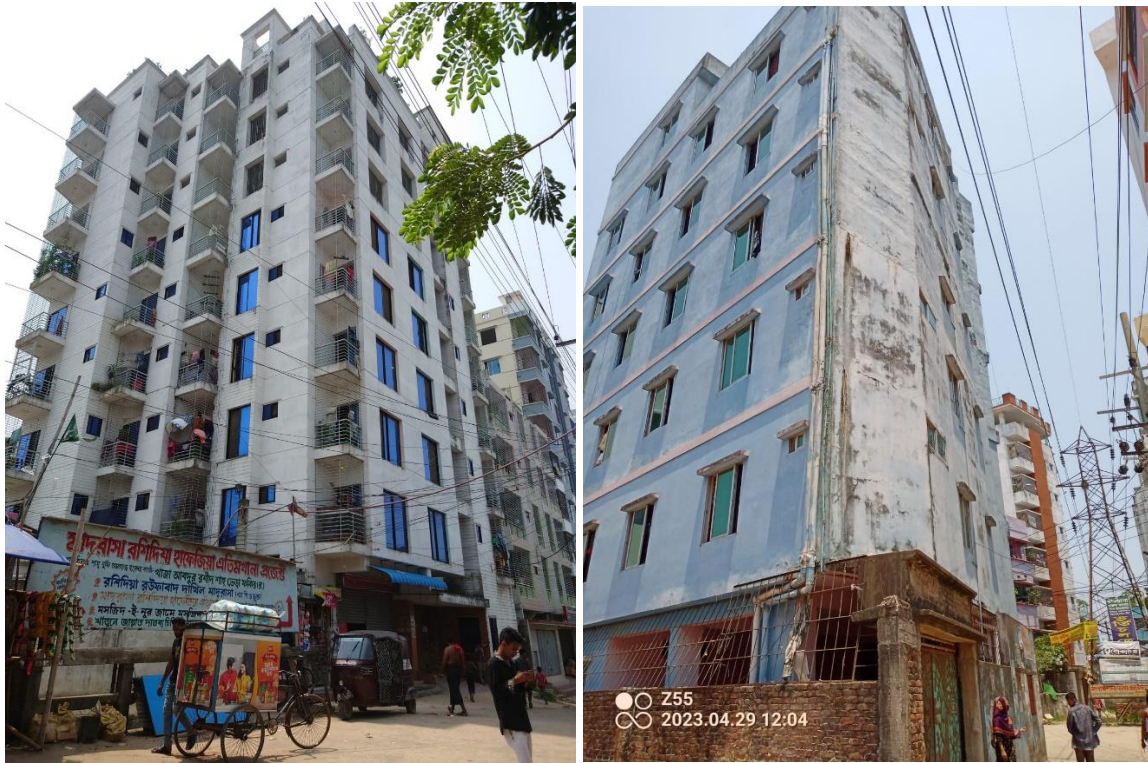
**Figure 2.16:** Typical plan irregularities of buildings in Chattogram city

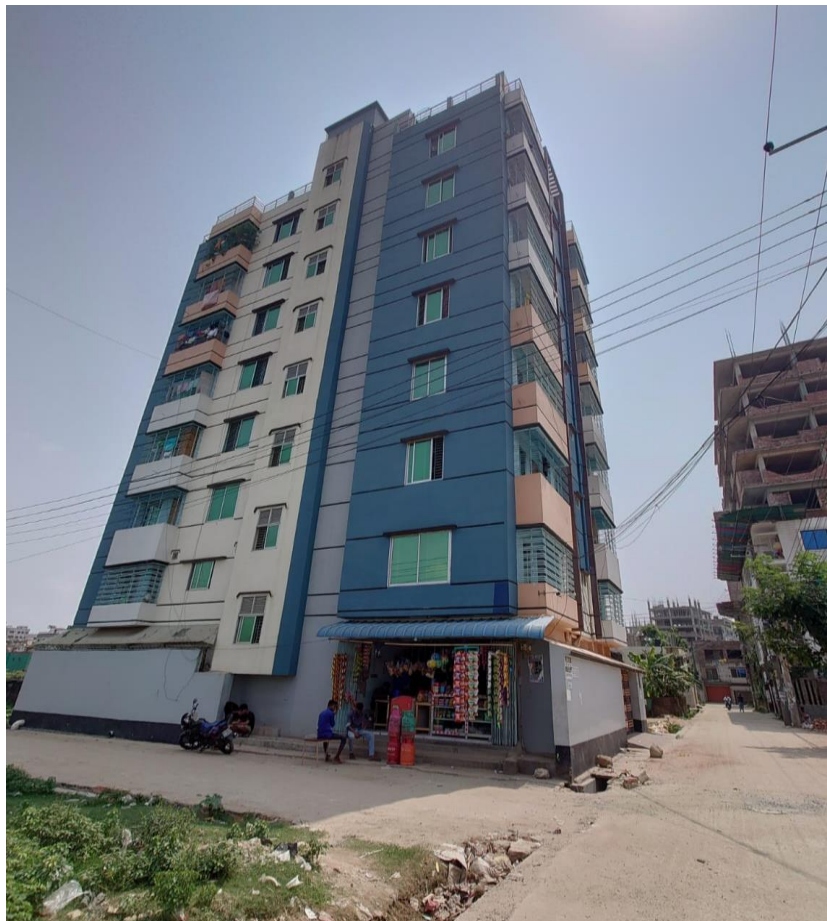
**Figure 2.17:** Front road width of a typical building in Chattogram city

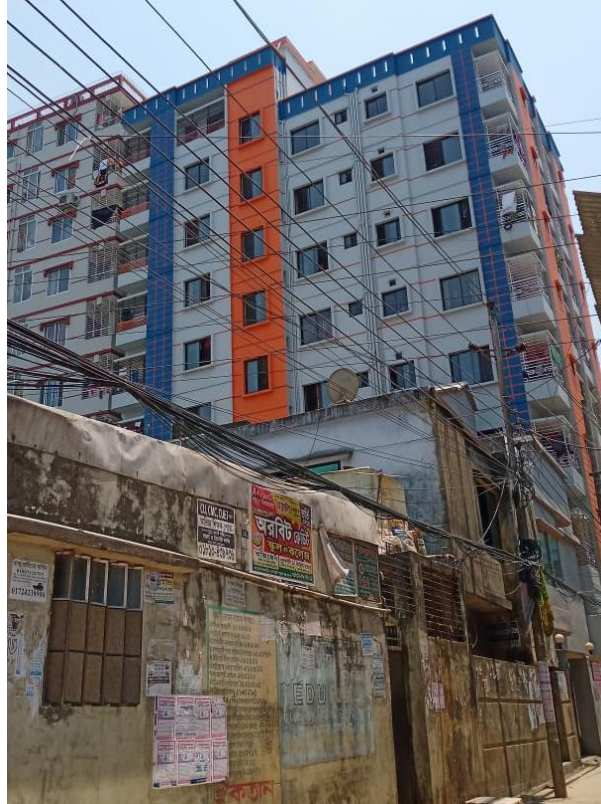
**Figure 2.18:** Pounding possibility due to adjacent building location
