LANDSLIDE INVENTORY IN AN URBAN SETTING IN THE CONTEXT OF CHITTAGONG METROPOLITAN AREA, BANGLADESH

ABSTRACT

Chittagong Metropolitan Area (CMA) is vulnerable to landslide hazards with an increasing trend infrequency and damage. Devastating landslides have hit CMA repeatedly in recent years. Under a project financed through ICIMOD of Nepal, detail survey has been conducted to prepare an inventory of landslides in CMA. Landslide events have been observed to occur at times of much higher rainfall amount compared to the monthly average. Moreover, rapid urbanization, increased population density, improper land-use, cutting of hills, indiscriminate deforestation and agricultural practices are aggravating the landslide vulnerability in CMA. A landslide inventory is helpful for landslide modelling, runoff modelling and urban land-use planning. A three step methodology, identifying past landslide events from news archive, information from local people and satellite image interpretation has been followed. An inventory of 57 landslide events has been prepared which includes landslide locations, types, dimension, activity, potential causes of landslides, triggering mechanism and slope stabili

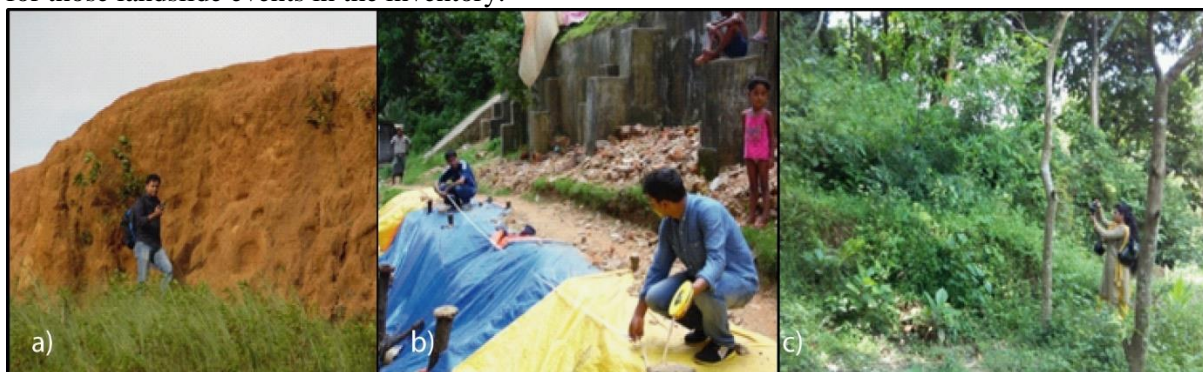
Figure 1: Field Survey (a) Taking GPS measurement (Latitude, longitude, and elevation) (b) Measuring displacement of mass, (c) Taking Photographs; Source: Field Survey, August, 2014

During the field survey, it was difficult to identify the exact landslide occurrence locations. Land cover alteration process remove the signature of landslides. In this field visit, information on location name, coordinates (latitude, longitude), area of displacement mass, rainfall information, landslide mechanism (type of movement, state, distribution, style, water content, material), existing land cover/ use type, causes of movement, landslide history (date of occurrence, duration of rainfall), consequences (casualties, injuries, damages, impacts) and future risk of landslide were collected as much as was available. Location name was collected by interviewing people. Coordinate values of landslide locations was determined by using GPS [Fig.1-a]. In case of some restricted/unreachable places, information was collected through interpreting Google earth image. The displacement of mass has been measured where possible [Fig.1-b]. Ground photographs of landslide site taken during field visit has also been added to the inventory [Fig.1-c]. Besides, landslide mechanism, causes of movement, landslide history and consequences have been collected from the local people as the collected documents could not provide sufficient information. The daily rainfall during and before the event from Bangladesh Meteorological Department is added to the inventory. However, for some landslide events, the exact date could not be found, as a result the rainfall data could not be provided for those landslide events in the inventory.

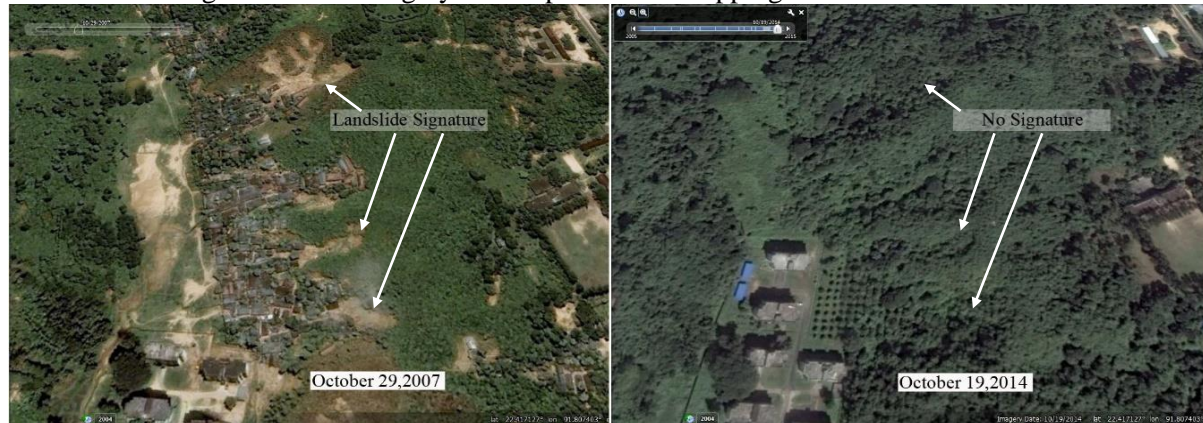
Figure 2: Image shows the signature of October 29, 2007 landslide (left) and the current situation during field visit in October 19, 2014 (right); Source: Google Earth

Many landslides have been identified, however some of the information was difficult to find, for instance the surface area of displaced mass. The signatures of past landslide have been removed through land cover alteration and morphological change [Fig.2]. The goal is to draw the polygon of displacement mass to support landslide studies based on landslide density (e.g. empirical modelling such as information value, weights of evidence). The Google Earth time slider tool is providing free access to fine resolution (pan-sharpened submeter originally 2.5m DigitalGlobe image) historic image.

The visual image interpretations technique has been applied to draw the polygon around the displacement mass. The figure 2 shows Kaichaghona area near Chittagong cantonment where a devastating landslide in June 2007 took many lives from foothill slum. Documentation of such landslide events in these restricted area is much more challenging. The remote sensing imageries are useful to deal with these challenges. Landslide signature extraction from visual or digital interpretation of remote sensing time series imagery can help landslide mapping.

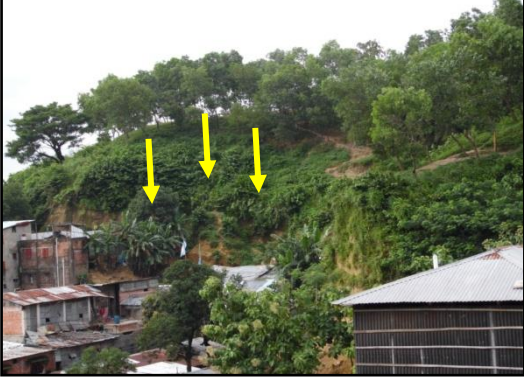
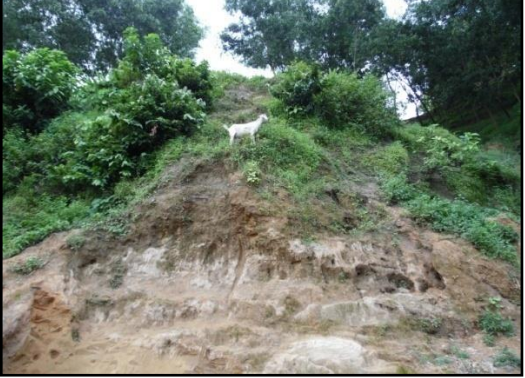
<p>Landslide ID :05 Landslide Location: Tanker Pahar, Motijhorna Coordinates: 22° 20'54.27"N, 91° 48'51.60"E</p>	<p>Datum: WGS 1984 Elevation (m): 41.18 Area of Displaced Mass (sqm): 331.84 Rainfall: Unknown</p>

<p>Source: <i>Field survey, August 2014</i></p>
<p>Landslide Mechanism</p>	
<p>Type of Movement: Slide State: Active, Reactivated, Suspended Distribution: Advancing</p>	<p>Style: Single Water Content: Moist Material: Soil/Earth</p>
<p>Land Cover/Use Type (%): Herbaceous vegetation is the Primary land cover of Tanker Pahar. Forest/ woodland type is also visible in this hill.</p>	
<p>Causes of Movement: Hill cutting is the major issue that caused landslide in this area and intense rainfall acted as a triggering factor for landslide.</p>	
<p>Land Slide History and Future Risk of Landslide</p>	
<p>Landslide in this site occurred in 1982, 1989, 1991, 1994, 1996 and 2013. 10 houses got damaged and almost 22 people died due to landslide at different periods. Utility facilities were highly damaged in this incident. Economic activities were hampered so does the social life of people. Environment has been found to be severely damaged. Still there are many houses located at the down slope of the hill. Soil of this site has been found to be sandy. The escapement slope is found to be near vertical. The failed mass is a part of upper portion. Vertical Slope characteristics can be considered as a contributing factor to future landslide for this hill. Settlements located at the down slope of this hill are at a huge risk of massive landslide. The risk is high (Field survey, August 2014).</p>
