**Assessment of Seismic Vulnerability of
Typical RC Garments Building of Chattogram City Corporation**

**A Thesis/Project
Submitted By
MD. HEDAYET ULLAH**

**MASTER OF ENGINEERING
in
Disaster Engineering and Management**

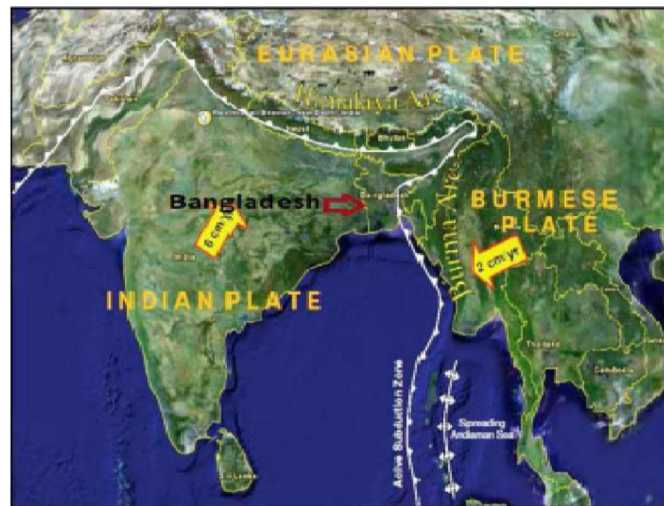
Figure 2-1: Plate Boundary between Indian and Eurasian plate,
(Background: Google Earth)

Bangladesh is situated at the intersection of three tectonic plates: the Indian Plate, the Eurasian Plate, and the Burma Plate, as illustrated in Figure 2-1. To the north of Bangladesh, the Indian Plate converges with the Eurasian Plate, while in the east, the Burma Plate intersects with the Indian Plate. The Indian Plate is moving northeast, and the Burma Plate is moving northwest. Additionally, the Shillong Plateau fault lies to the north of Bangladesh, with the east-west trending Dauki Fault running along the southern edge of the Shillong Plateau, as shown in Figure 2-1. The Dauki Fault may extend to the northern part of the subduction fault in Sylhet [23, 27].

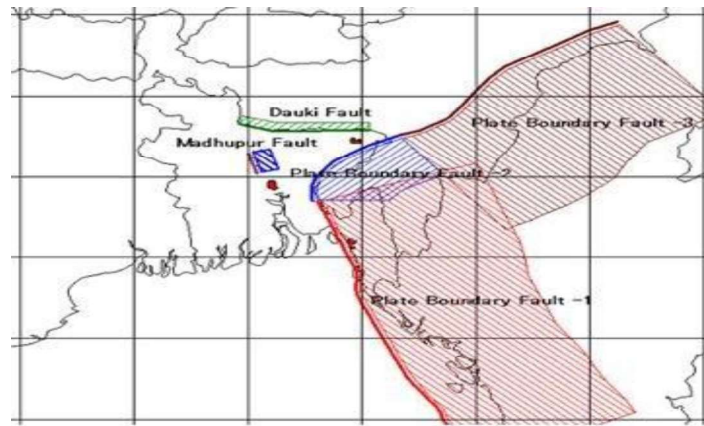
Figure 2-2: Scenario Earthquake Fault Model, Adapted from [11]

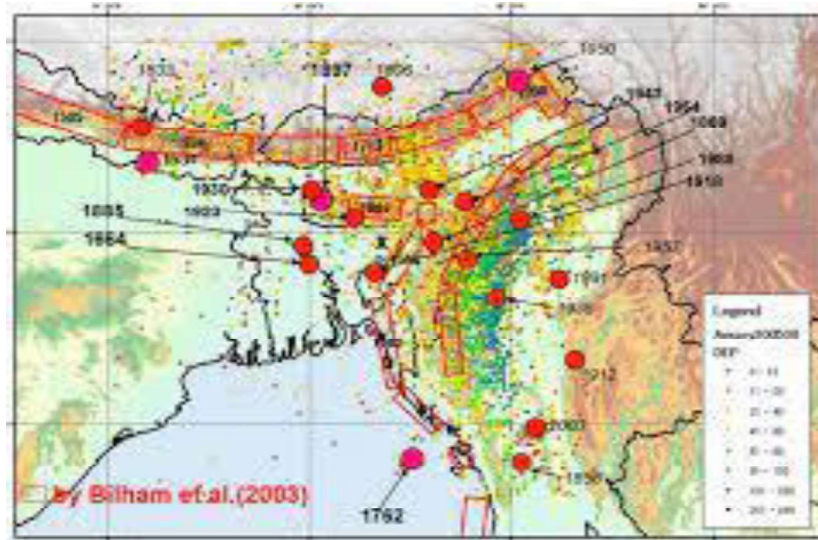
Figure 2-3: Epicenter of Historical Earthquakes from 1664 to 2007 [11].

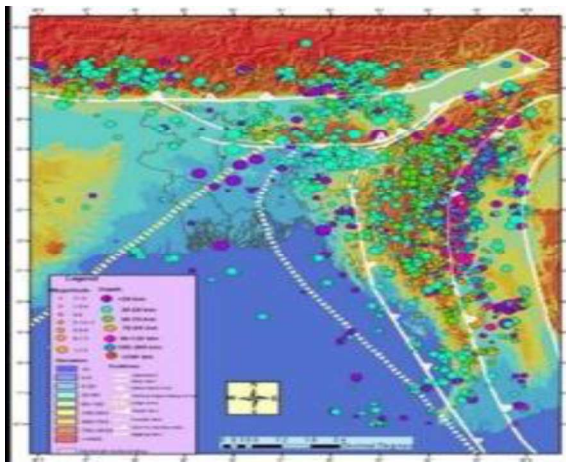
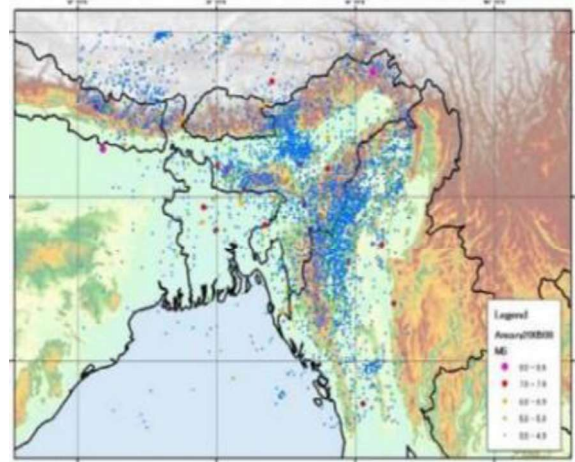
(a) Earthquake Magnitude in and Around Bangladesh

(b) Depth and Source Region of Historical Earthquakes

Figure 2-4: Seismicity in Bangladesh, from [11]

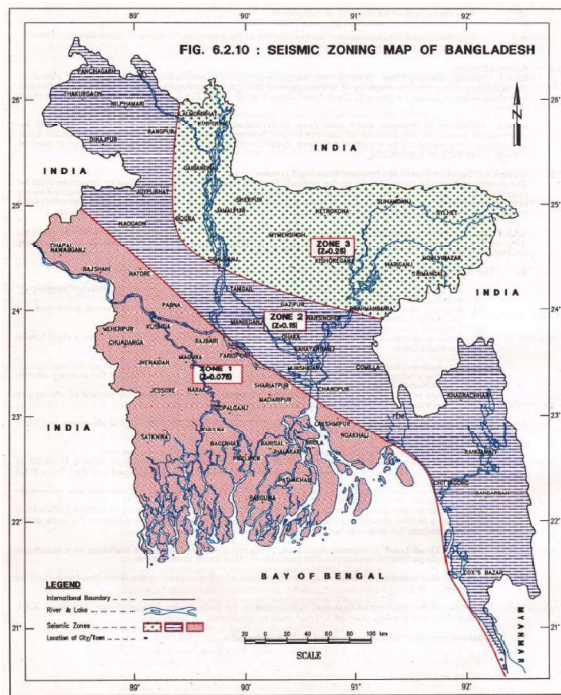
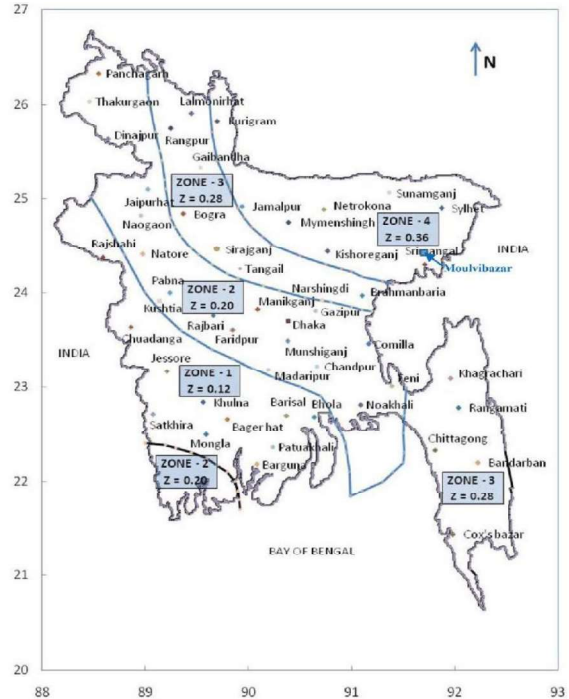
a) Seismic Zoning Map in BNBC 1993

b) Seismic Zoning Map in BNBC 2020

Figure 2-5: Seismic Zoning Map of Bangladesh, Adapted [15]

According to the seismic zoning map of Bangladesh, the country is divided into several seismic zones based on maximum expected ground motions (forces) for earthquakes likely to occur in a specific zone or area. The country was divided into three generalized seismic zones according to BNBC 1993 as shown in Figure 2-5.a, with zone coefficient Z equal to 0.25 (zone-I), 0.15 (zone-II), and 0.075 (zone-III). According to a study by Bolt [13], it appears that the seismic zoning and zone co-efficient of BNBC 1993 are not consistent with those of the neighboring country India and it is felt that the seismic zoning of BNBC is required to be upgraded. With this in line, again the basis of the Maximum Credible Earthquake (MCE) with a return period of 2475 years has been introduced in the building code BNBC 2020. As depicted in Figure 2-5.b, Bangladesh's seismic zoning map is divided into four seismic zones, each with a corresponding zone coefficient: Zone 1 has a coefficient of 0.12, Zone 2 has 0.2, Zone 3 has 0.28, and Zone 4 has 0.36. This coefficient signifies the Peak Ground Acceleration (PGA) value on rock or very stiff soil sites [22, 28, 35].

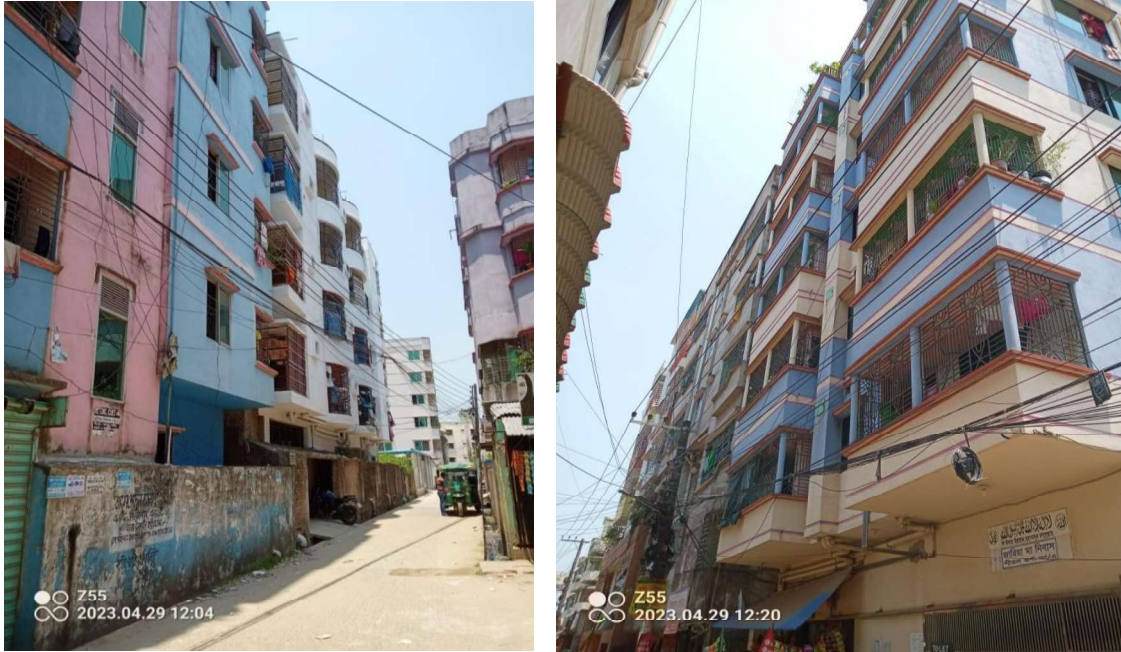
Figure 2-8: View of Typical Adjacent Buildings in a Residential Area Chattogram City

Adjacent buildings refer to two or more buildings that are next to each other or nearby, typically sharing a common boundary or wall. These buildings can be residential, commercial, or industrial structures and may be owned by the same person or by different parties. Adjacent buildings can have a significant impact on each other's structural integrity, insulation, and overall safety. Therefore, building codes and regulations often require specific standards and guidelines for the construction and maintenance of adjacent buildings to ensure their safety and the safety of those who use them [32-34].

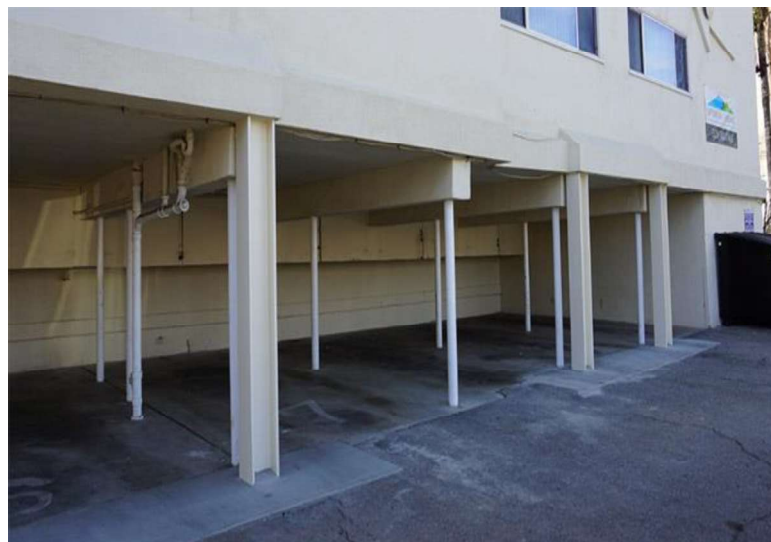
Figure 2-9: Soft Story in a Building

Building a soft story refers to constructing a structure with a ground floor that is designed to be more flexible than the upper floors. This approach is typically used in buildings with a large open ground floor, such as retail stores, parking garages, and other commercial properties [46-47].

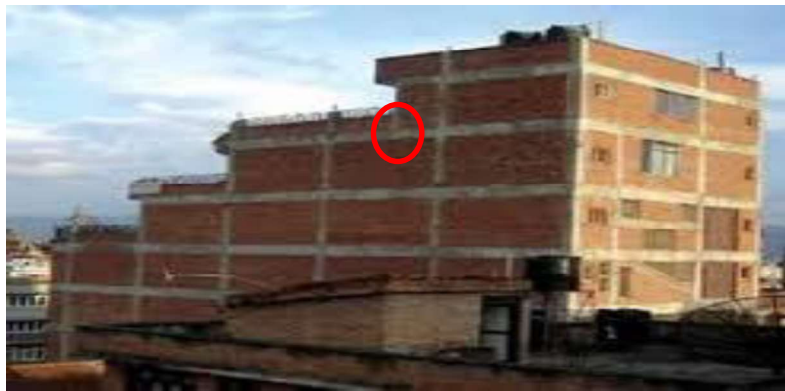
Figure 2-10: Building Vertical Discontinuities

Building vertical discontinuities refer to breaks or changes in the vertical plane or elevation of a building's structure, facade, or interior design. These changes may include alterations in the height or width of a building, variations in the materials used in construction, changes in the architectural style or design elements, or transitions between different uses or functions of a building. Vertical discontinuities can occur within a single building or across a group of buildings in a particular area. They can be intentional, such as when designers use contrasting materials or colors to create a visual break between different sections of a building. Alternatively, vertical discontinuities can be accidental or a result of changes made over time without considering the overall design impact [46-47].

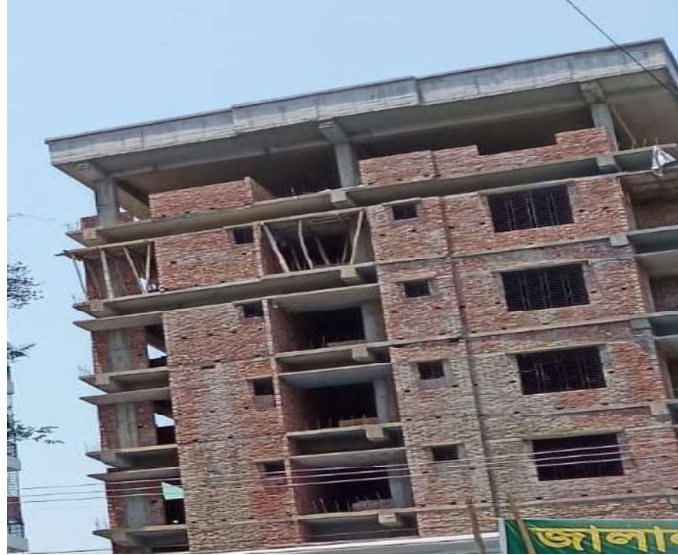
Figure 2-11: Masonry Units in a Typical Building of Chattogram City

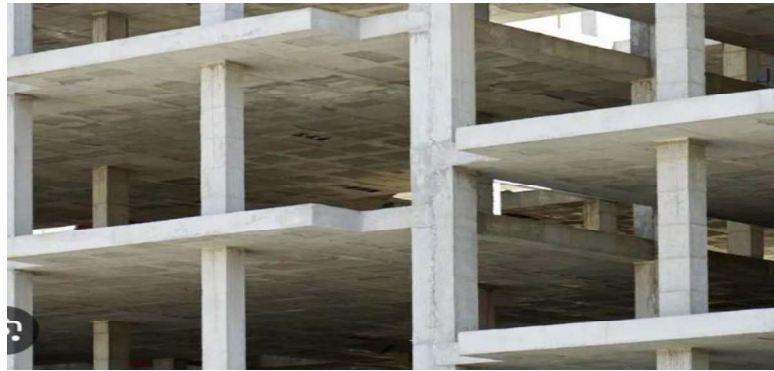
Figure 2-12: Flat Slabs

In a flat slab structure, the slab is directly supported by columns or walls, without any intermediary beams or girders. This is achieved by thickening the slab at the column locations to provide additional strength and support. The flat slab can also be reinforced with steel bars or mesh to provide additional tensile strength and prevent cracking.

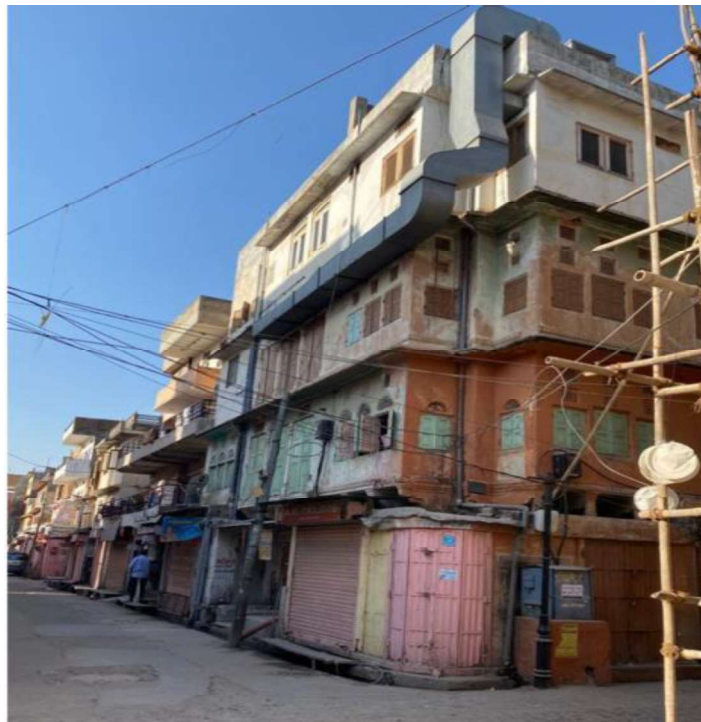
Figure 2-13: Typical Plan Irregularities in Buildings

Plan irregularities can have a significant impact on the structural design of a building and may require additional analysis and design considerations to ensure the building's stability and performance. Proper detailing, material selection, and construction techniques may be required to mitigate the effects of plan irregularities and ensure the safety and durability of the building. Building codes and standards often provide guidance and requirements for addressing plan irregularities in building design [46-47].

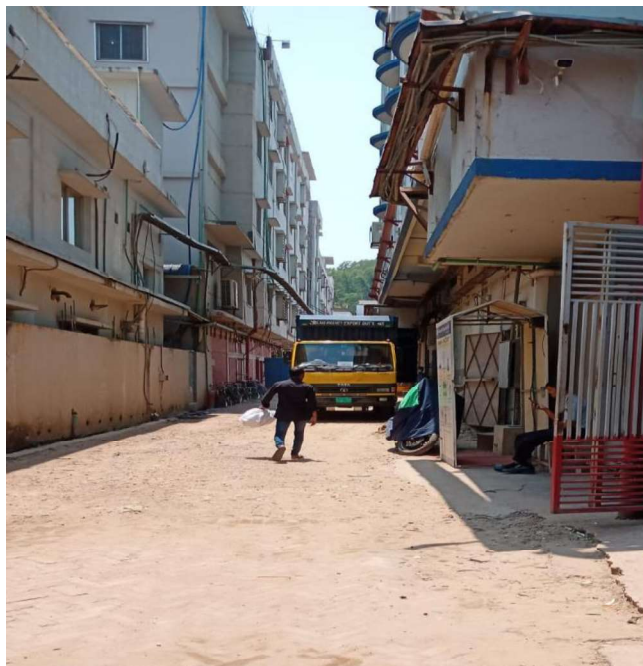
Figure 2-14: Typical Condition of Front Road Width of a Garments Building of Chattogram

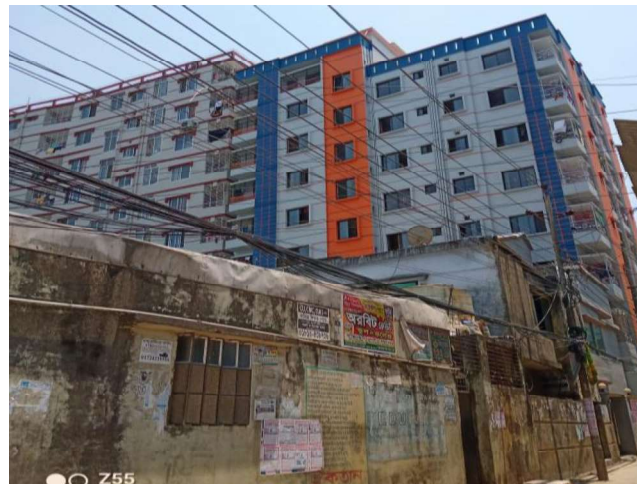
Figure 2-15: Pounding Possibility due to Closely Adjacent Building Location

Building near tall buildings can pose certain risks and considerations. The Structural considerations of foundations and the structural integrity of a building may be influenced by the presence of adjacent buildings. Potential concerns include differential settlement, ground vibration, and the impact of neighboring construction activities. The Emergency access and egress presence of tall buildings near a new structure can potentially complicate emergency access and egress routes. Adequate planning and coordination are required to ensure proper access to emergency vehicles and evacuation procedures in case of emergencies [46-47].

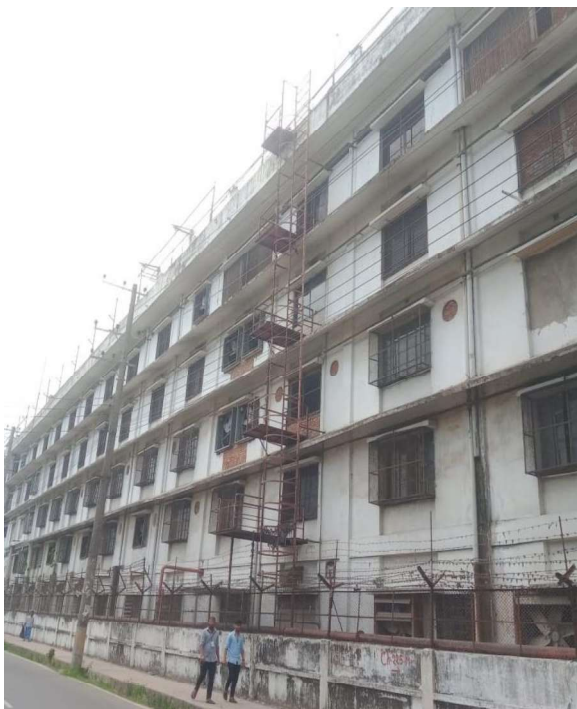
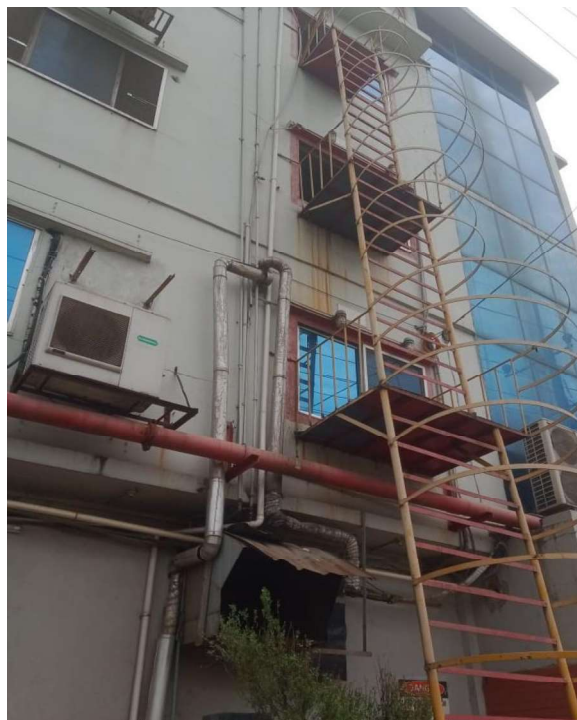
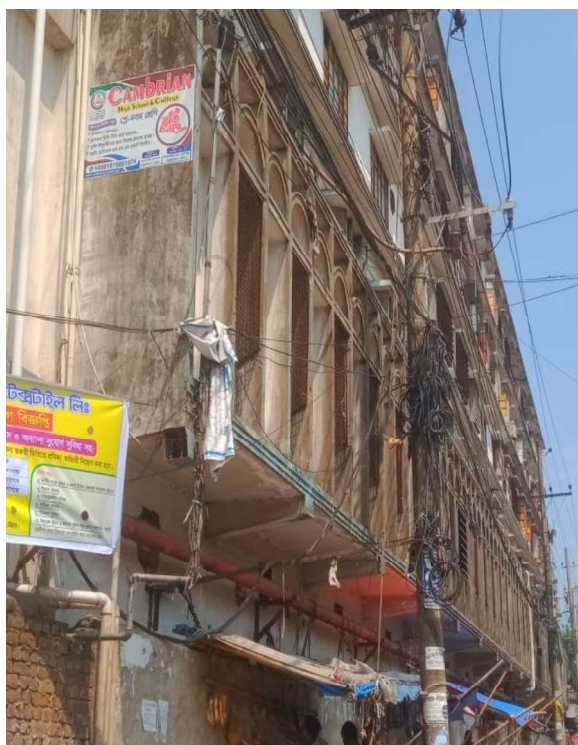
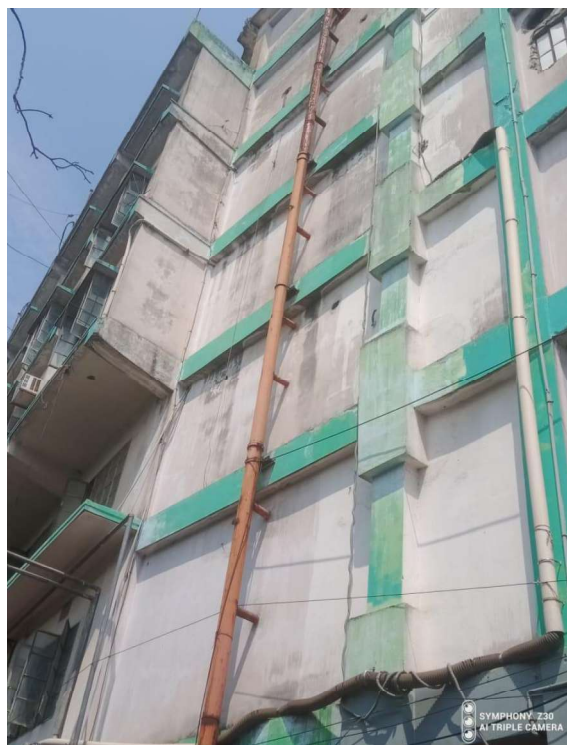
3-2(a): An RMG Building at Panchlaish Ward no. 3

3-2(b): An RMG Building at Chandgaon Ward no. 4

3-2(c): An RMG Building, West.Sholoshahar Ward no. 7 **3-2(d):** An RMG Building, North Agrabad Ward no. 24

Figure 3-2: Typical Conditions of RMG Industrial Buildings in Chattogram City Corporation

The area to be surveyed for seismic vulnerability assessment of typical RC garment buildings of Chattogram city was selected after a pre-field survey conducted in Ward No-3, Ward No-4, Ward No-7, Ward No-24, and Ward No-2 of Chattogram area. A total of 86 buildings were surveyed by simple random sampling procedure and typical conditions of buildings were assessed by visual observations done by walk-down survey. Figures 3-2(a) to 3-2(d) show typical conditions of garment buildings of different wards in Chattogram city. Most of the buildings are typical RC moment-resisting frame structures not exceeding 5 stories in height. Some of them are not even purpose-built for industrial use. Underground levels of most of the buildings are constructed as soft story levels with designated use reserved for parking, loading-unloading areas, etc. Unreinforced heavy masonry works are built on cantilever parts in many of the buildings at the upper story level.

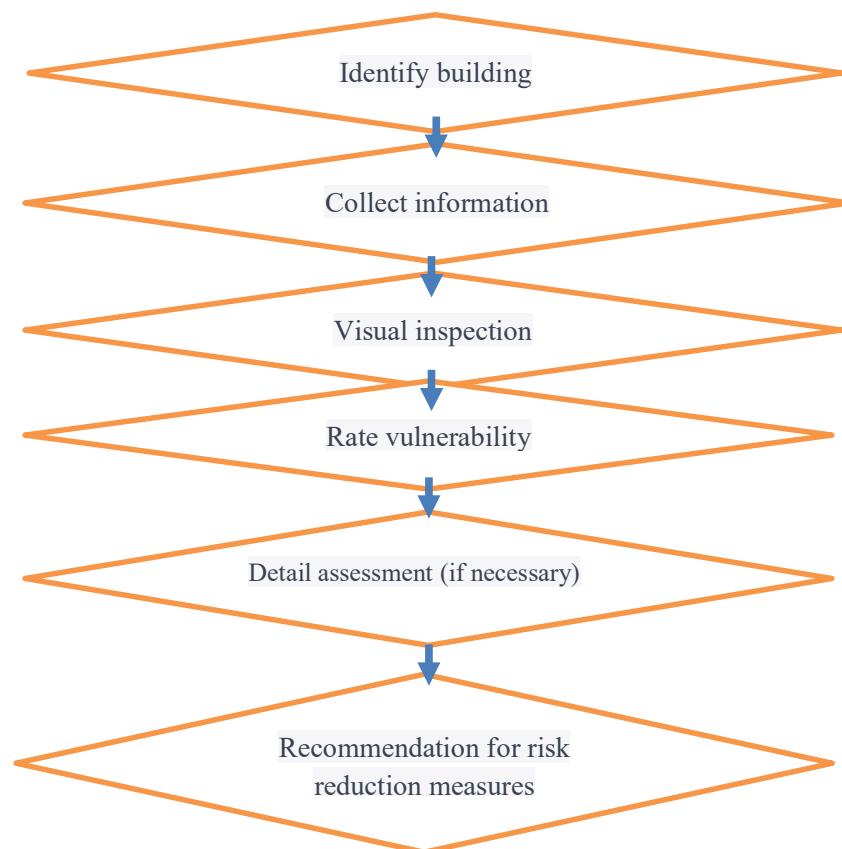
Figure 3-4: Schematic Diagram of Workflow Chart of RVS for Seismic Vulnerability Assessment

Methodological steps of the RVS methods are as follows which is also shown in the schematic diagram of Figure 3.3.

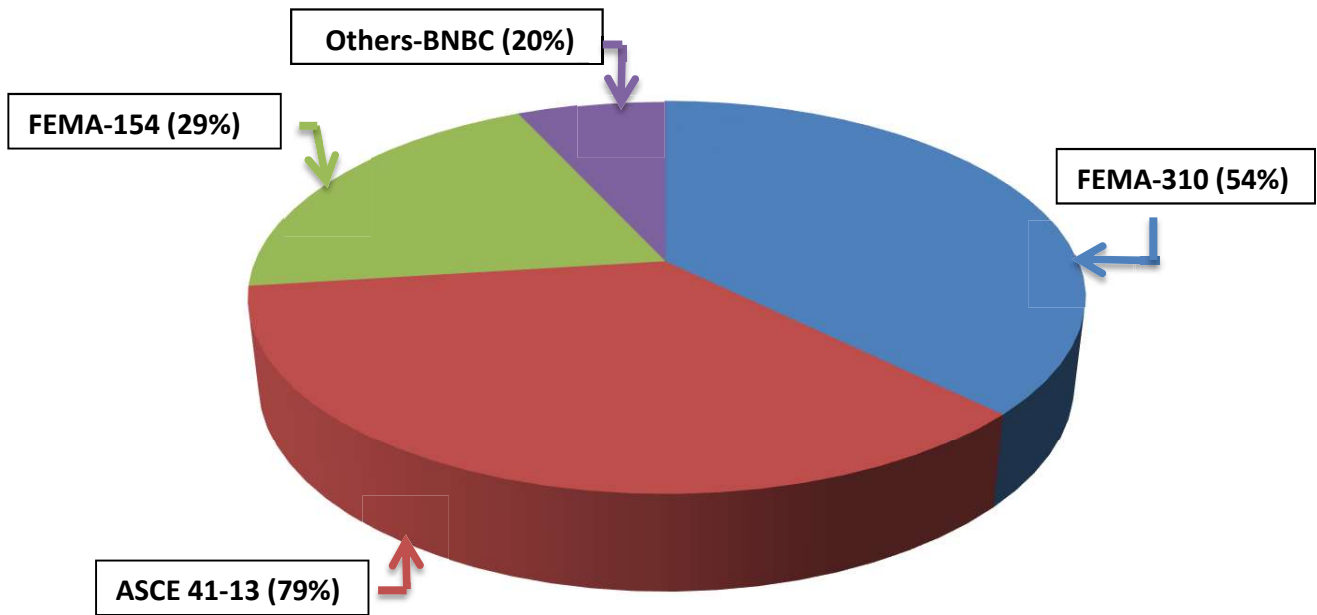
Figure 4-1: Seismic Vulnerability of Reinforced Concrete RMG Buildings in the Study Area

According to the FEMA-154 method, 29% of the selected buildings are assessed to score below the cut-off score. On average, the selected buildings do not satisfy 54% and 79% of the respective vulnerability criteria according to FEMA-310 and ASCE 41-13 methods of Tier-1 assessment. The selected buildings of the project area do not satisfy 20% of the selected criteria as per selected BNBC guidelines of Table 3-3.

Important findings of the survey are analyzed and a summary of the results of seismic vulnerability assessed according to different methods or criteria is presented in Figure 4.1. A cut-off score of 2.5 has been used for the FEMA 154 method of seismic vulnerability while non-compliance with one or more vulnerability parameters of FEMA 310 or ASCE 41-13 are considered as vulnerability conditions according to those RVS methods of assessment.

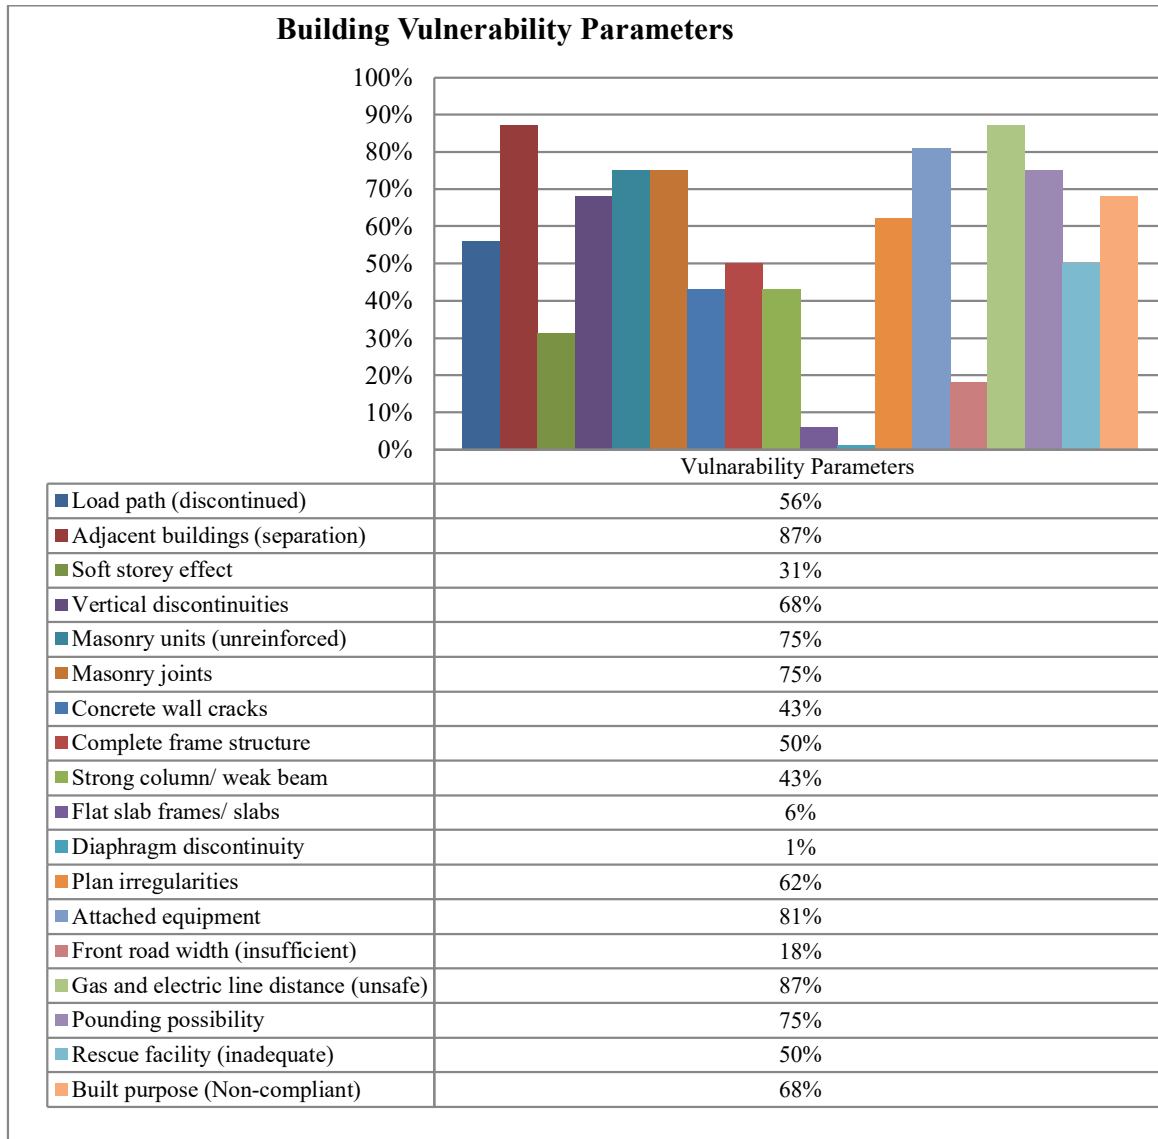
Figure 4-2: Building Vulnerability (%) due to Global or Local Vulnerability Parameters

irregularities or load path, vertical discontinuity, etc. If all important vulnerability parameters are mutually considered in different methods, the results of the integrated assessment for seismic vulnerability of the RC buildings could become consistent regardless of the methods used for seismic vulnerability assessment. A summary of findings of analysis done in this connection including important parameters of seismic vulnerability is summarized as shown in Figure 4-2.

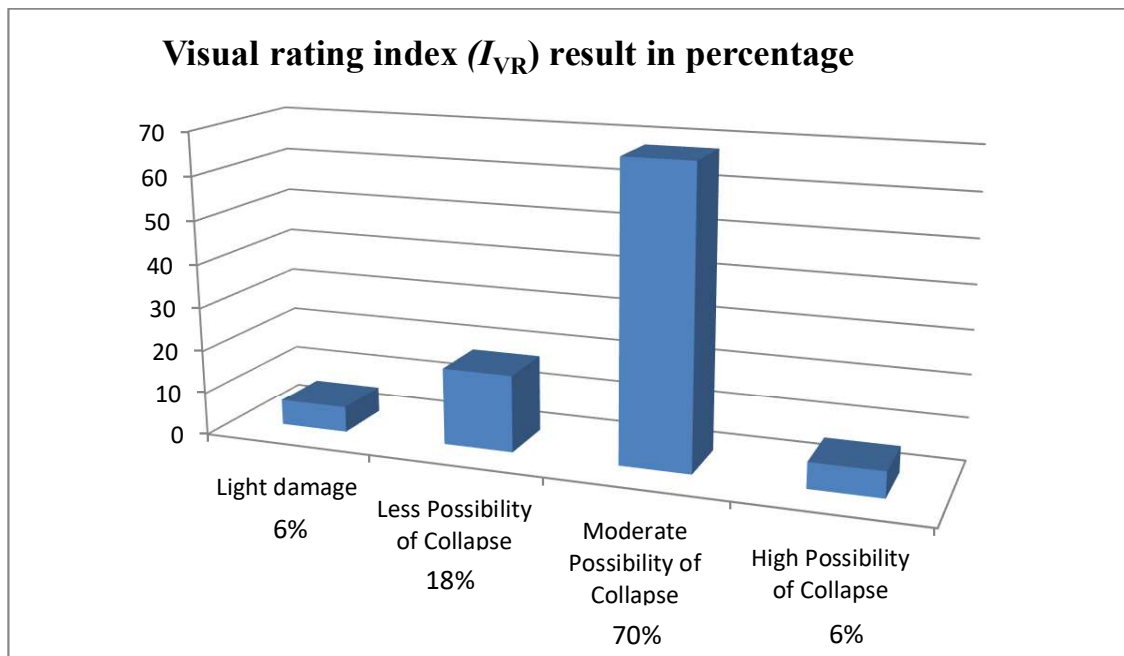
Figure 4-3: Seismic Capacity (I_{VR} , in %) of RC Garments Buildings of Study Area
