**Vulnerability Assessment of Typical Residential Buildings of  
Chattogram City Corporation with Post Seismic Hazard Consideration**

**DEPARTMENT OF DISASTER ENGINEERING AND MANAGEMENT  
CHITTAGONG UNIVERSITY OF ENGINEERING & TECHNOLOGY  
CHITTAGONG, BANGLADESH  
December, 2024**

**A Project Report**

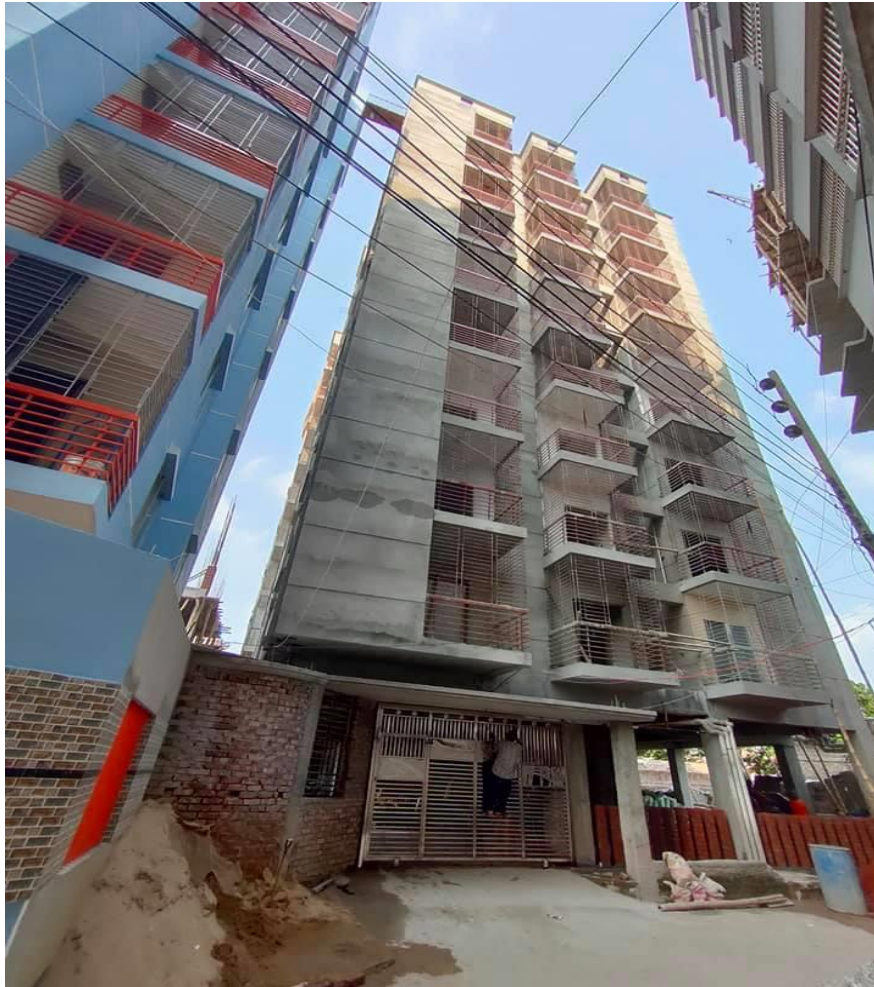
**Figure 2.9:** Soft story building

The lateral-force-resisting system's stiffness within each story must not fall below 70% of the stiffness in an adjacent story above or below, nor should it be less than 80% of the average stiffness of the three adjacent stories for both Life-Safety and Immediate Occupancy considerations. Geometric irregularities are typically identified by scrutinizing variations in

the dimensions of the lateral-force-resisting system from one story to another. Another example is a story in a high-rise that is set back for architectural reasons. (FEMA, 1985)

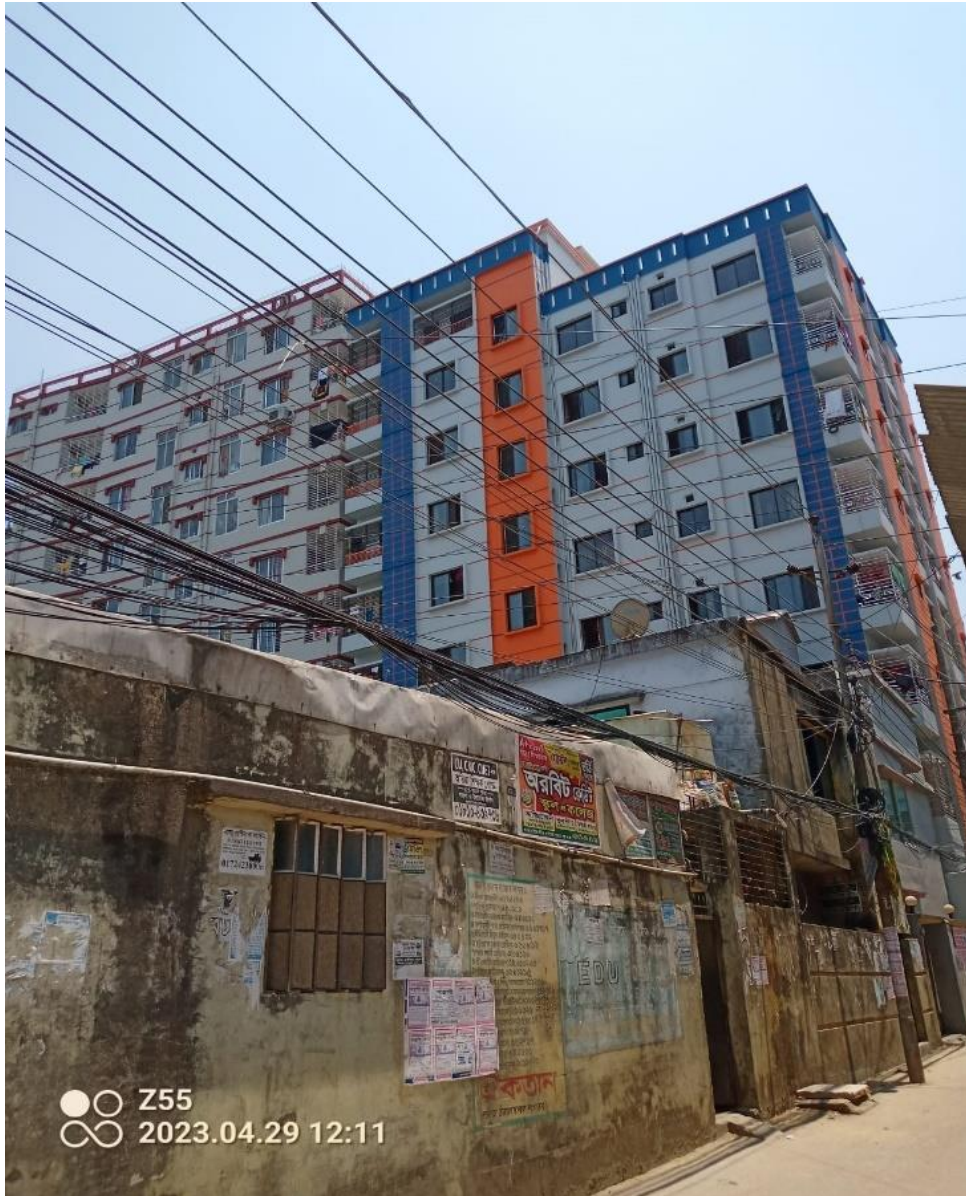
**Figure 2.11:** Building vertical discontinuities

Vertical elements in the lateral-force-resisting system must maintain a continuous connection to the foundation, with common instances of discontinuity, such as in shear walls or braced frames, detected through visual observation. Concerns arise in buildings with significant torsion, as it leads to added seismic demands and lateral drifts on vertical elements due to diaphragm rotation. It is recommended to design structures with a balanced system initially, as intentionally introducing torsion can compromise earthquake performance.

Vertical discontinuities can occur within a single building or across a group of buildings in a particular area. They can be intentional, such as when designers use contrasting materials or colours to create a visual break between different sections of a building. Alternatively, vertical discontinuities can be accidental or a result of changes made over time without considering the overall design impact. (FEMA, 1985)
